Long-term corrosion protection for bridge cables with butyl rubber tapes using the ATIS Cableskin® system

ATIS Cableskin® is a corrosion protection system for bridge cables which uses proven materials to strike out in a new direction. These innovative ideas mean that, for the first time, corrosion protection work on scaffolds and in enclosures will be a thing of the past, and the costs and traffic restrictions are massively reduced. It is worth highlighting the extremely long lifetime of this corrosion protection.

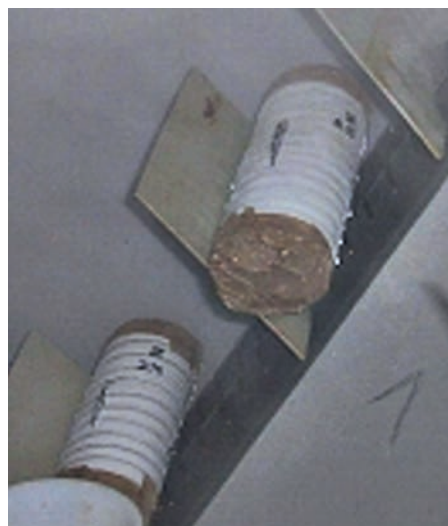
Fig. 3. How the base layer adheres to and meshes with the cable surface

Interdiffusion of the butyl rubber molecules, so-called cold welding, Fig. 2c, forms a tube-like encasement, which adheres very well to the cable surface and meshes with it, Fig. 3. It is practically impermeable to oxygen and water vapour.

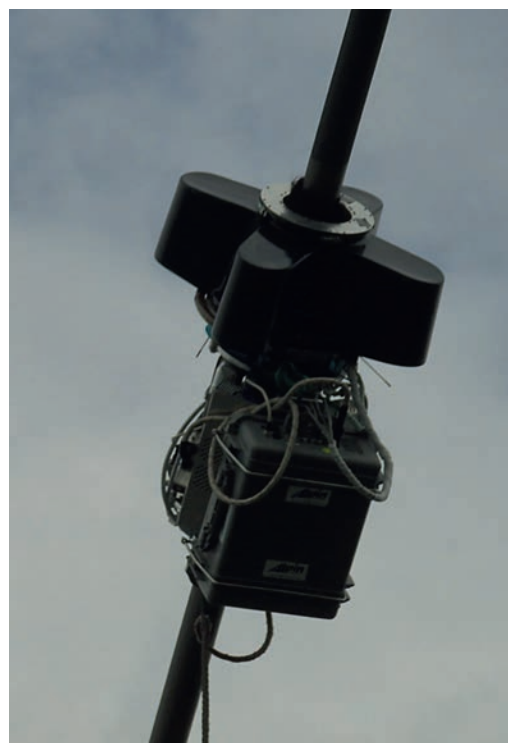
Fig. 5. Visual inspection with high-speed camera

- Direct visual inspection
- Inspection with video
- Inspection with high-resolution, high-speed cameras, Fig. 5

The advantage of the third procedure is that it supplies a sharp panorama image whose quality is equivalent to an on-site inspection and which captures the whole scale of the cable. The evaluation takes place with the help of a special analysis and comparison program.

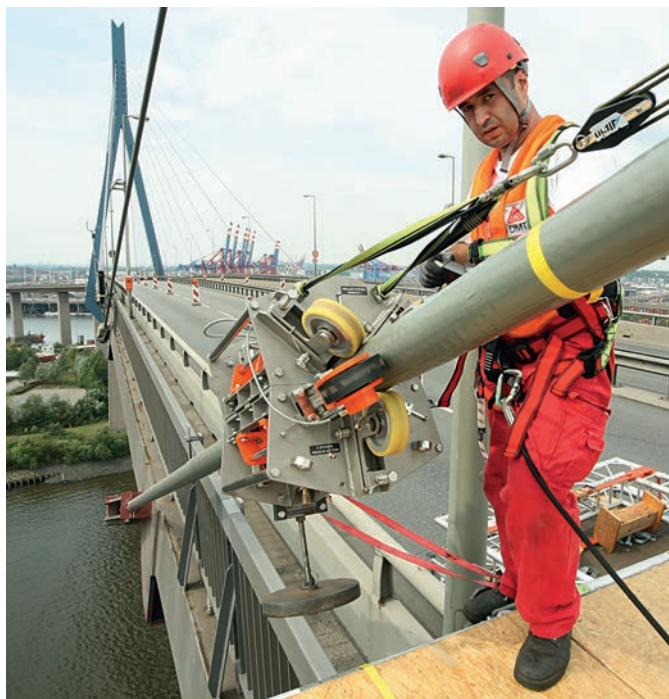
Fig. 6. Magnetic induction (MI) unit

High-performance devices are needed for this. Wire fractures across the entire cross-section are recorded, Fig. 6.

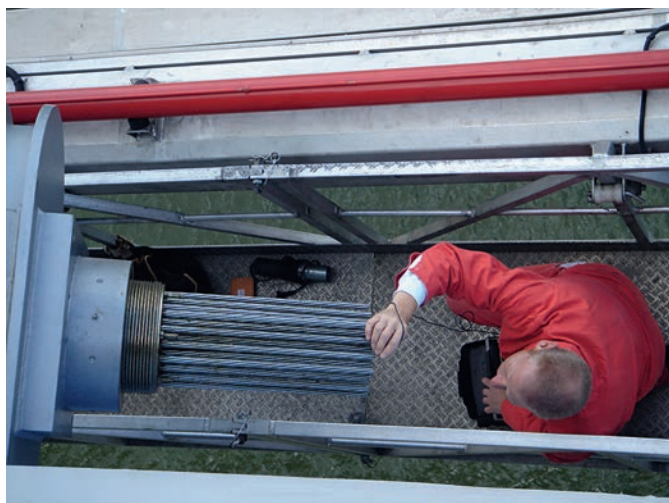
Fig. 7. Ultrasonic test

In places that cannot be checked with the MI procedure due to geometric design, e.g. anchorages areas, the ultrasonic procedure is employed, which allows wire fractures along a length of approx. 1.40 m to be detected with the help of a transducer placed on the end surface of each individual wire, Fig. 7.

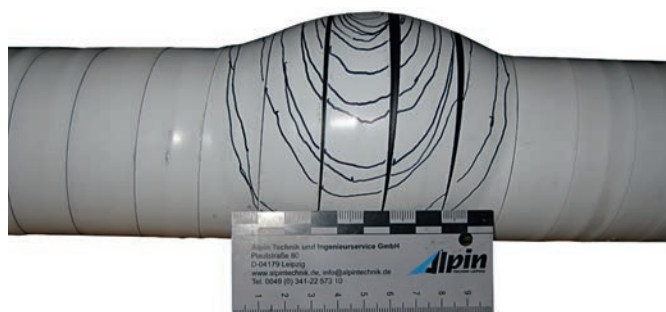
Fig. 8. Test sample subjected to 30 bar interior pressure under the wrapping

Cable filling material that has leaked out must be removed mechanically. No further measures are required. In tests involving applying an internal pressure of 30 bar, it was shown that the wrapping remains tight even under this extreme load, Fig. 8.

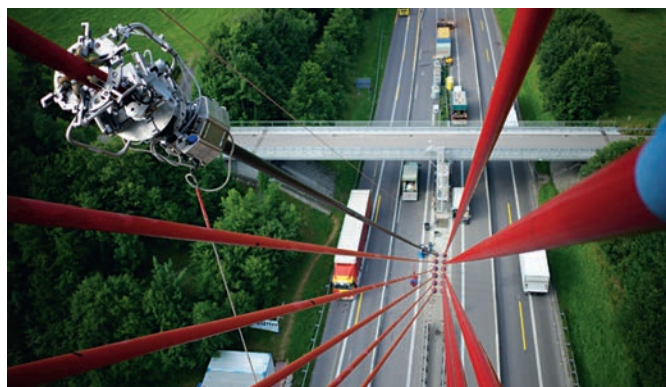
Fig. 9. Wrapping robot on painted cables

The butyl rubber tapes are usually applied to the cable automatically using a wrapping robot, Fig. 9. It moves along the cable independently and wraps the tape helically

under slight tension. Depending on the length and diameter of the cable, joints may be required, which are also produced automatically by the robot. All working steps are controlled from the ground by a monitoring unit and can be saved and archived so that the owner is able to closely monitor what is or was happening.

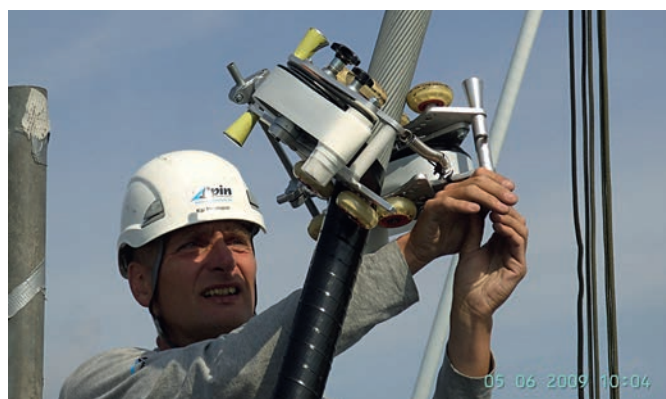
Fig. 10. Wrapping with hand unit

At places where the geometry does not allow the use of robots, the tape can be wrapped using a manually operated unit, Fig. 10 or directly by hand.

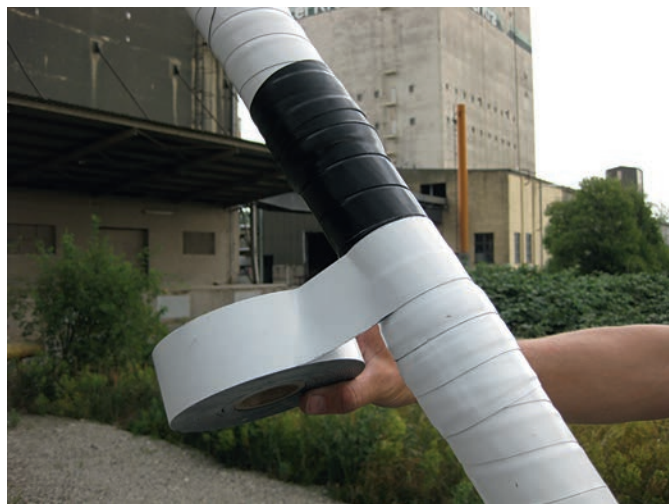
Fig. 11. Repairing damage

preparation. To do so, only the damaged area is cut out in circular shapes. The new tape is wrapped around by hand, overlapping the existing tapes, Fig. 11.

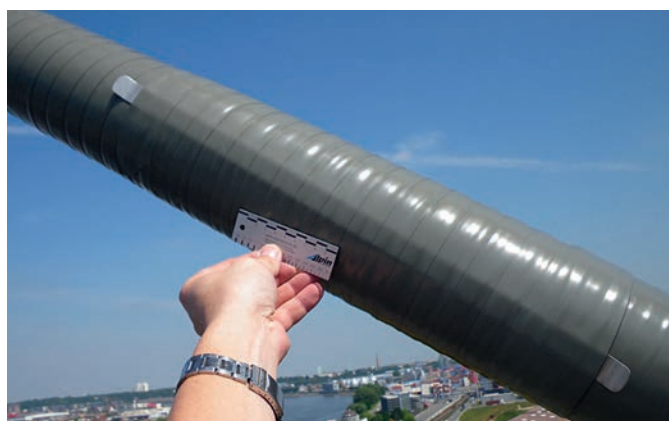
Fig. 12. Control area on wrapping

If damage to the existing intact wrapping is to be avoided when carrying out such control tests, an alternative to this is available. An additional 50 cm long wrapping, which can be easily removed while taking appropriate precautions, is applied to the existing wrapping. This allows the corrosion protection performance to be assessed in an easy and careful way under the conditions prevailing at the structure, Fig. 12.

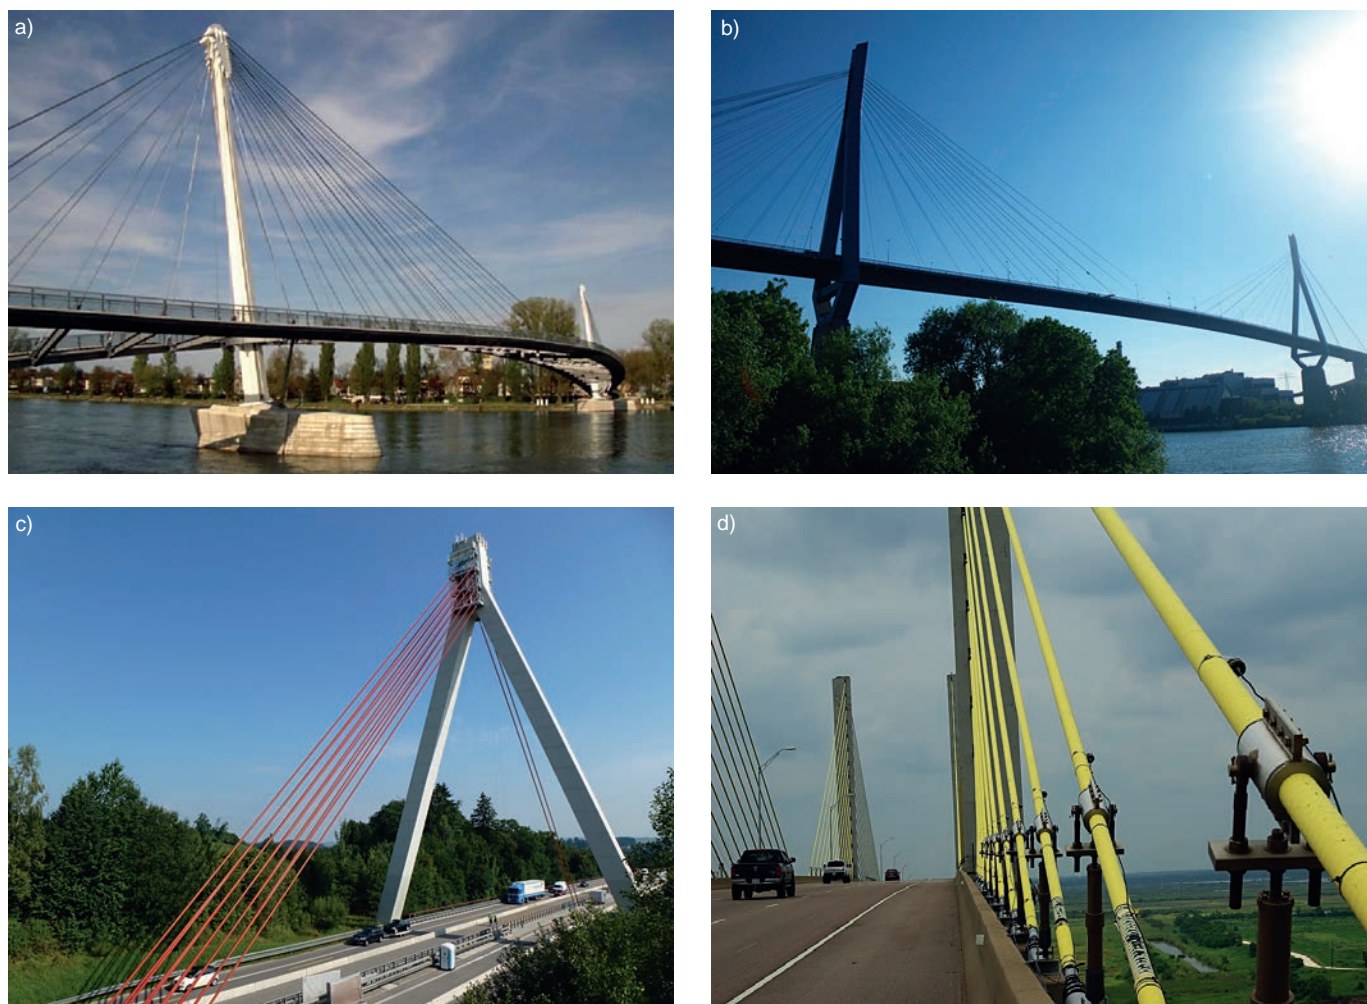
Fig. 15. Applications: a) Passerelle des deux Rives, Kehl/Strasbourg, b) Köhlbrand Bridge, Hamburg, c) Obere Argen Bridge on A96 motorway, Wangen/Allgäu, d) Veterans Memorial Bridge, Port Arthur, Texas, USA

First of all, in 2008 it was used for the 80 stay cables of the Passerelle des deux Rives pedestrian and cycle bridge over the Rhine at Kehl/Strasbourg (\varnothing 60 mm to \varnothing 139 mm, total stay cable length approx. 3700 m). The works were performed four years after completing the bridge. No special preparation of the galvanized cable surface was carried out, Fig. 15a [9].

In 2010 the Köhlbrand Bridge in the port of Hamburg followed with 88 cables (up to \varnothing 118 mm, approx. 8700 m in total). The cables had been in use since 1978 and were PU-covered. The butyl rubber tapes were applied after manual removal of loose paint coats. Adhesive coating was not removed, Fig. 15b [10].

In 2012 the cables of the Obere Argen Bridge on the A96 motorway nearby Wangen, Allgäu, Germany, were wrapped (24 cables, \varnothing 126 mm, total of approx. 1700 m). The existing coating was not removed here, either, Fig. 15c [11].

13000 m²), with the main aim of improving their resistance against UV rays, has started in December 2014 and will take about six months, Fig. 15d.
