CABLE TECHNOLOGY

SKIN TIGHT

A hybrid system being retrofitted to protect the main cables of a bridge in Norway leaves the option of future dehumidification open. **Eric Kuhn** explains

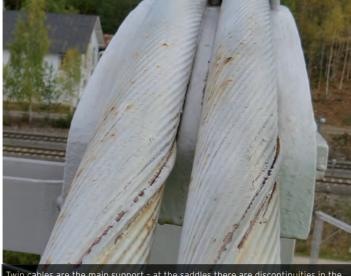
Twin cables are the main support - at the saddles there are discontinuities in the outer wires

Despite the fact that they have several layers of protective paint on the cables, corrosion spots have been discovered over the years as well as discontinuities of the outer wires. Furthermore, the design of the hanger clamps prevents the use of a reliable conventional corrosion-protection system, creating a critical detail.

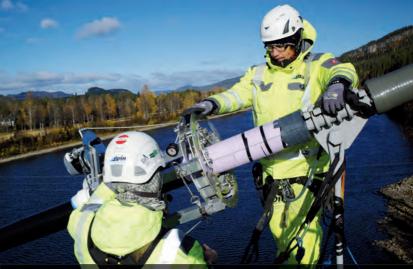
The twin cables are being enclosed in a foam moulding and wrapped with Cableskin

The twin cables on each panel on the main span are being surrounded with a closed cell of foam moulding. This forms a 150mm-diameter cable which retains a channel in the centre so that a dehumidification can be accommodated at a later date if necessary. The moulding is then wrapped with Atis Cableskin.

The twin cables on the main span were formed into a single unit by use of a closed cell foam moulding to create a single cable of approximately 150mm diameter. A channel was retained between them to allow installation of dehumification measures in future if required. The moulding was then wrapped with Cableskin.
